# CASE STUDY

Site description	Garbage containers collection truck
Treatment location	Interior of the truck where the garbage containers are collected
Location description	Standard collection truck
Characteristic smells	Garbage, organic breaking down
Active agent used	3 Gelactiv <sup>®</sup> cartridges (2 Gelactiv <sup>®</sup> AFG + 1 Gelactiv <sup>®</sup> B3)
Diffusion technology applied	Smellmeister <sup>®</sup> Truck linked to a diffusion ramp installed inside and in the back of the truck
Treatment renewal rate	1 cartridge per month (33%)

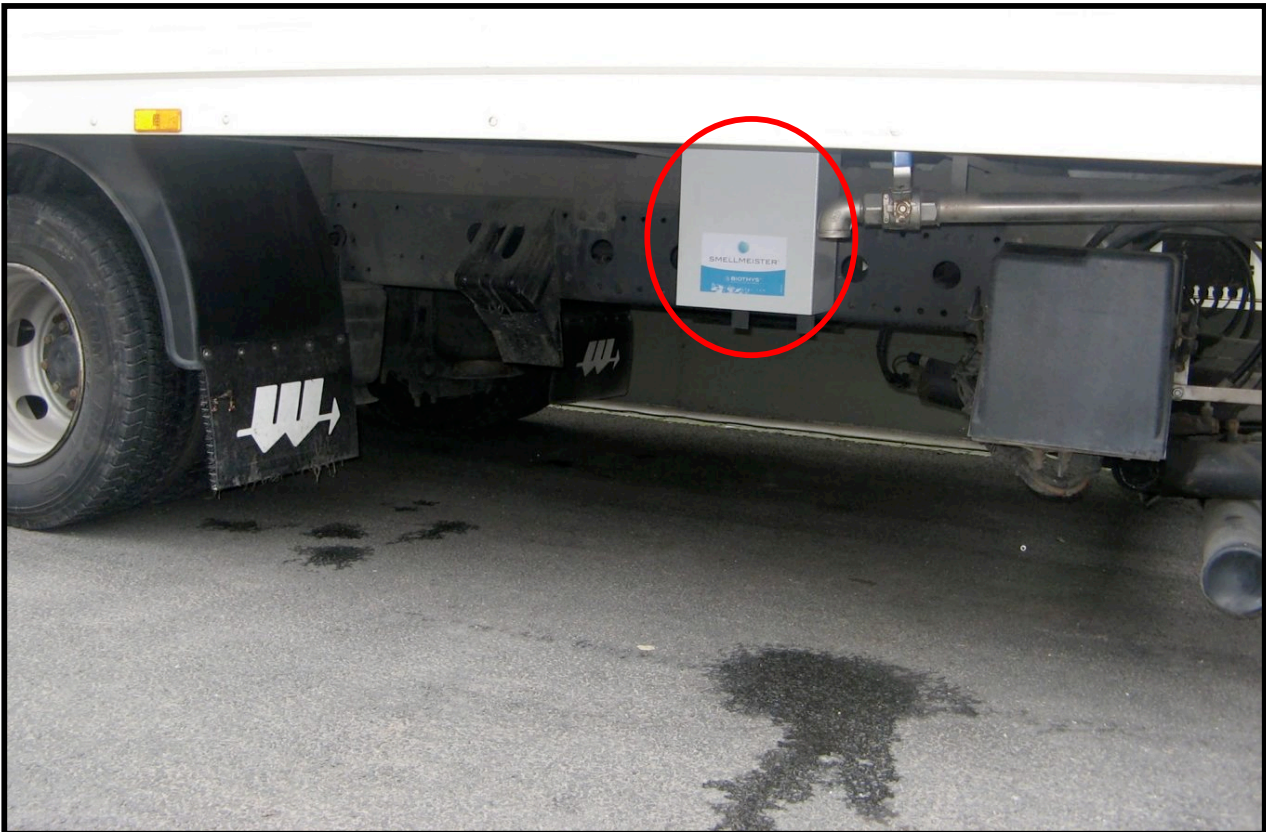
**View of the Smellmeister<sup>®</sup> Truck installed underneath the truck:**

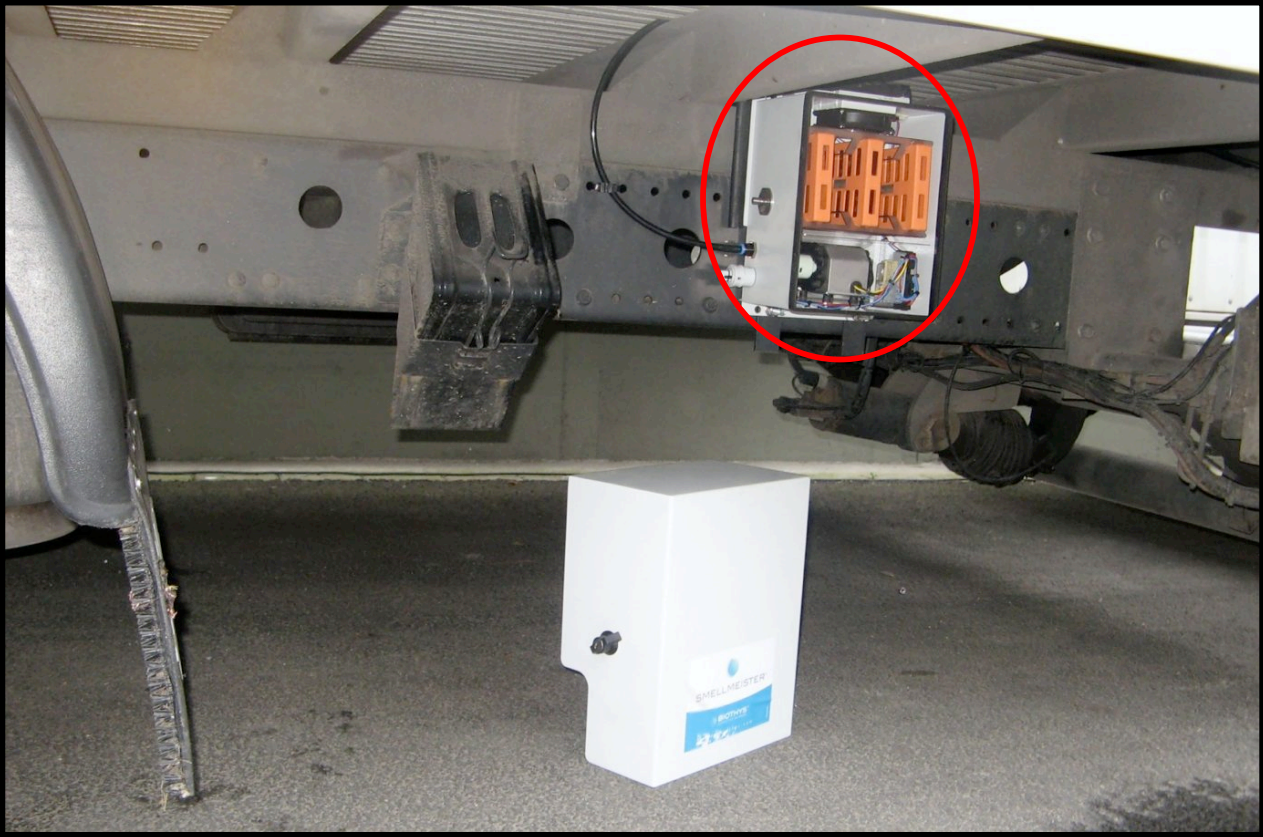
In depth view of the Smellmeister® Truck device underneath the truck:

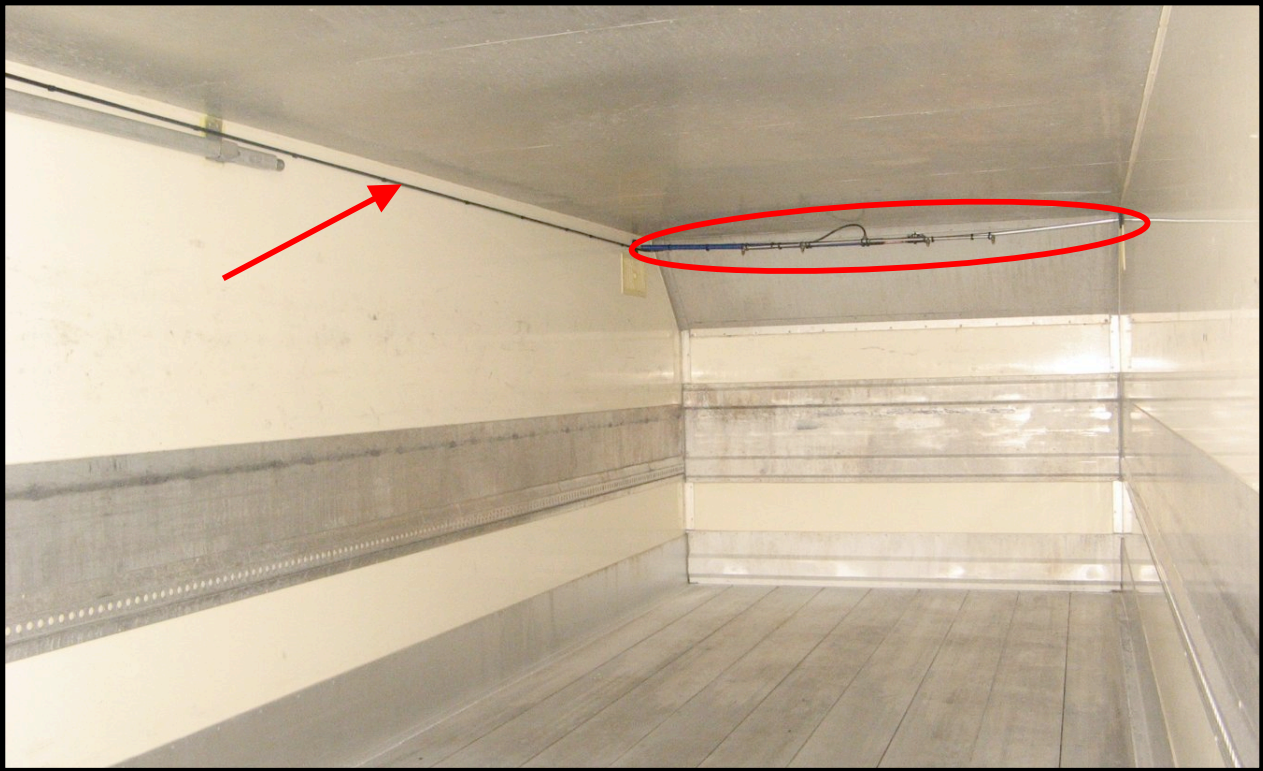
View of the diffusion ramp installed inside and in the back of the truck:
