CASE STUDY

Site description	Garbage collection truck
Treatment location	Garbage entry in the back of the truck
Location description	Standard collection truck
Characteristic smells	Garbage, organic breaking down
Active agent used	5 Gelactiv [®] cartridges (3 Gelactiv [®] AFG + 2 Gelactiv [®] B3)
Diffusion technology applied	Smellmeister [®] Truck linked to a diffusion ramp installed in the back of the truck
Treatment renewal rate	1 to 2 cartridges per month (20-40%)

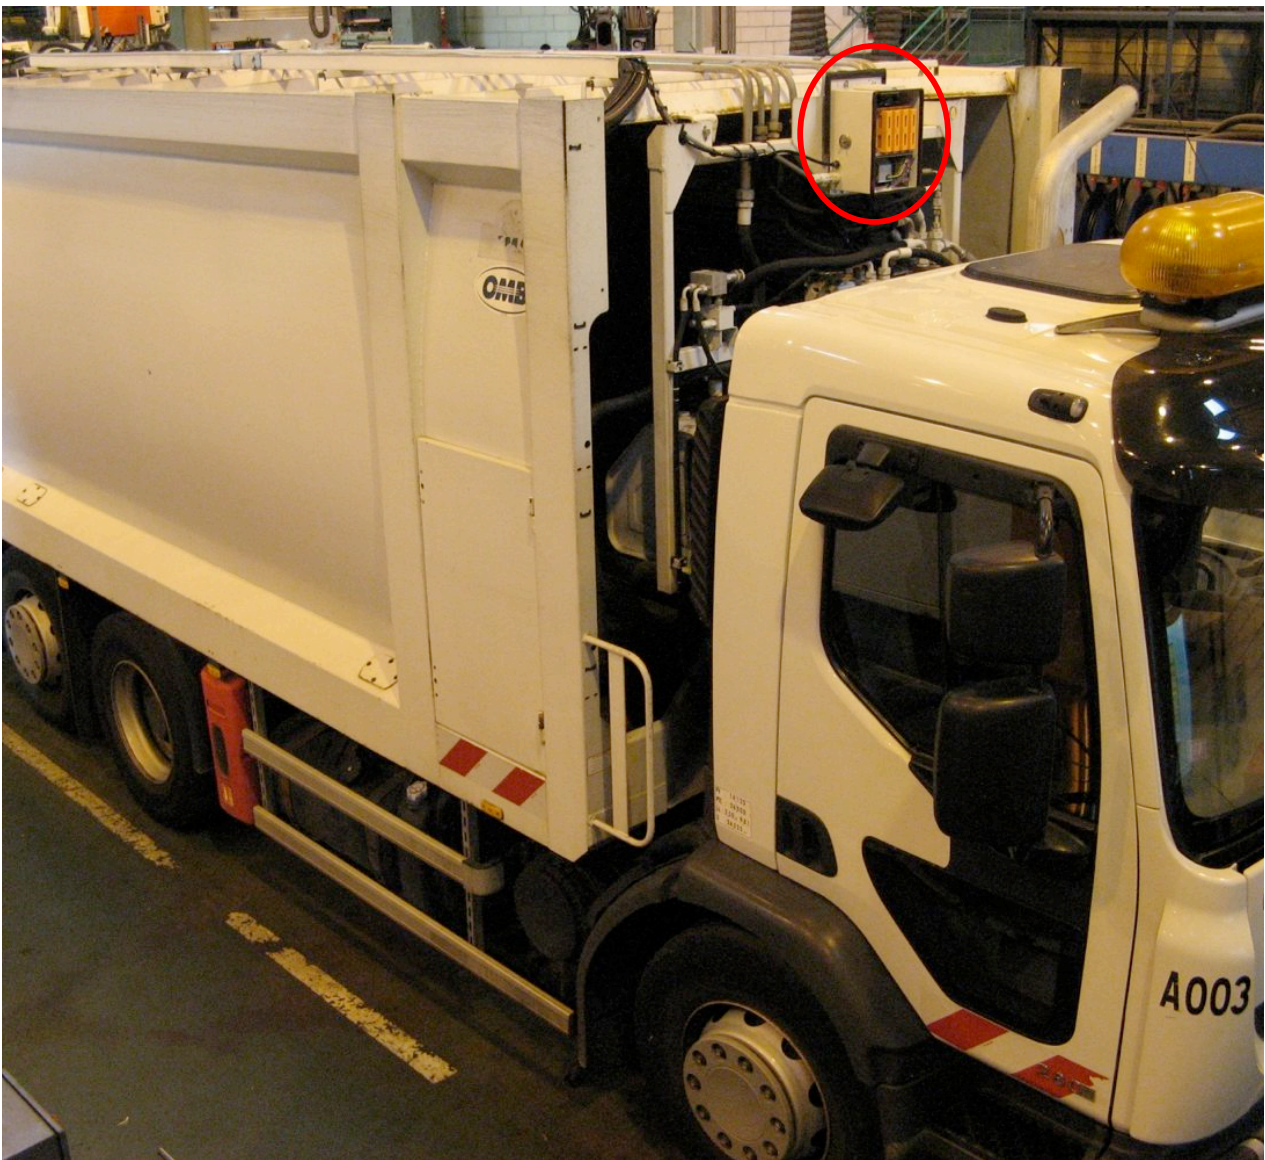
View of the Smellmeister[®] Truck device installed at the front of the truck:

Note: The Smellmeister[®] Truck device is supplied by the truck (24V) and only works when the truck is running.

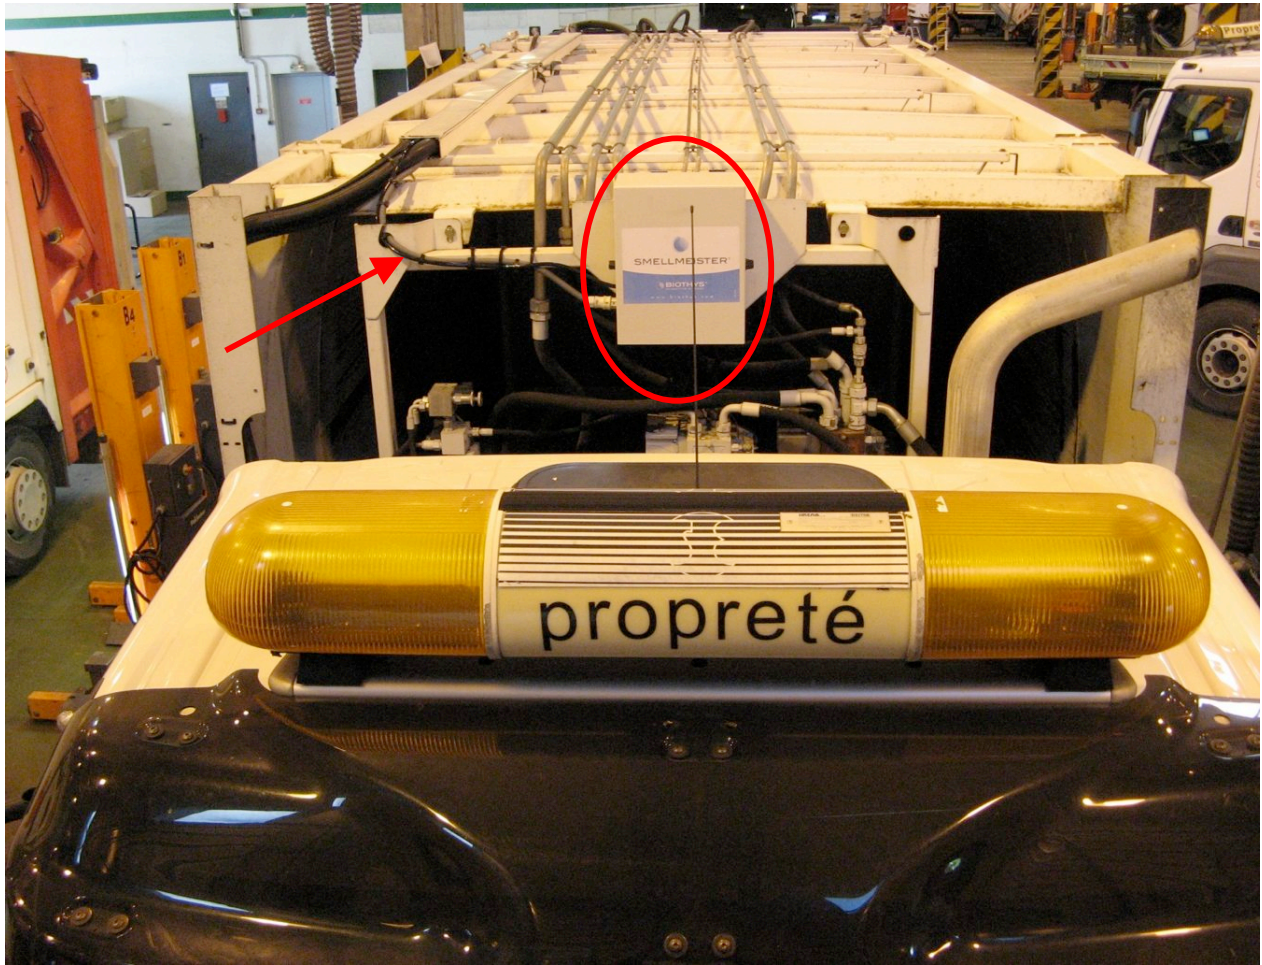
View of the Smellmeister® Truck device and the beginning of the diffusion pipe:

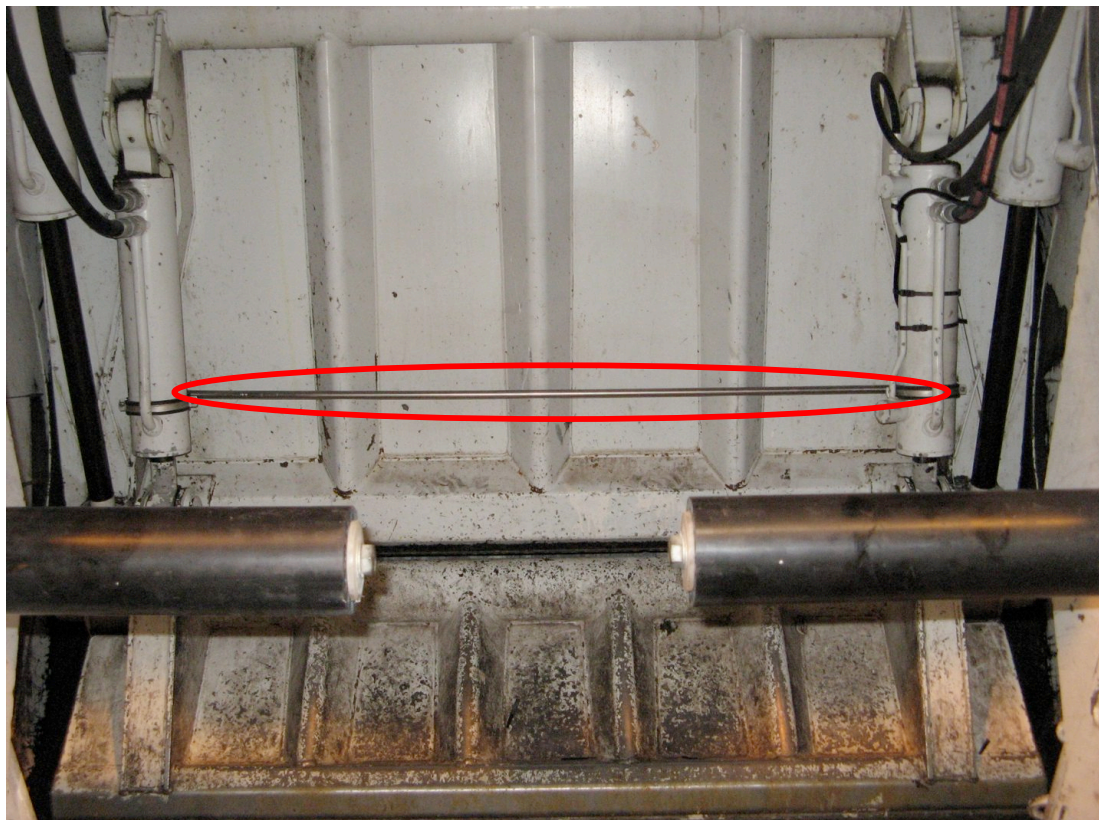
View of the diffusion ramp installed in the back of the truck:
